# Transportation Research Division

## **Technical Report 05-6**

*Full Depth Reclamation with Cement*

*Fourth Interim, December 2009*

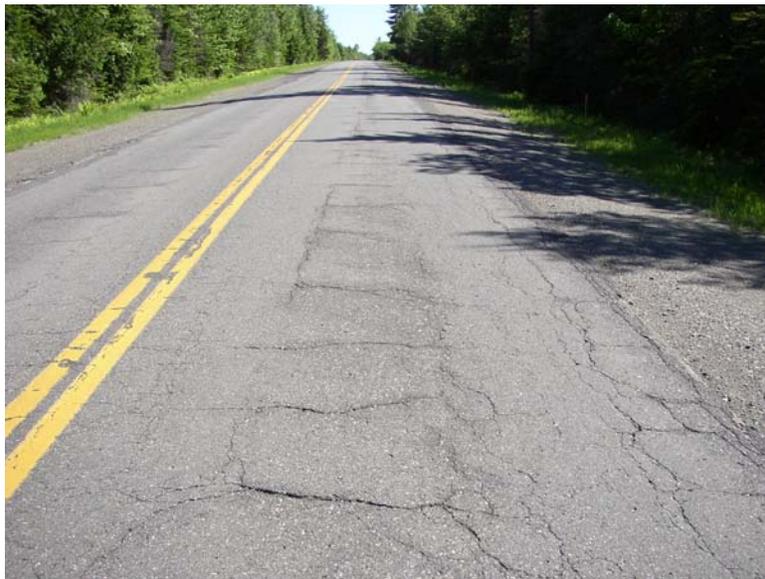
Project Identification Number (PIN) 11326.00 is located in Aroostook County on US Route 2A between the townships of North Yarmouth Academy Grant and Reed Plantation (Figure 1). The project is 5.02 miles in length and is scheduled for Highway Rehabilitation with drainage and safety improvements. Annual Average Daily Traffic is somewhat low at 700 in 2005 with 38 percent heavy trucks. Table 1 contains current (2005) and future (2017) traffic data. Prior treatments include a resurfacing in 1995 and a thin overlay of maintenance mix in 2001. The project has many areas with transverse, alligator, and block type cracks as displayed in Photo 1.

Photo 1: Typical Cracking in the North Lane

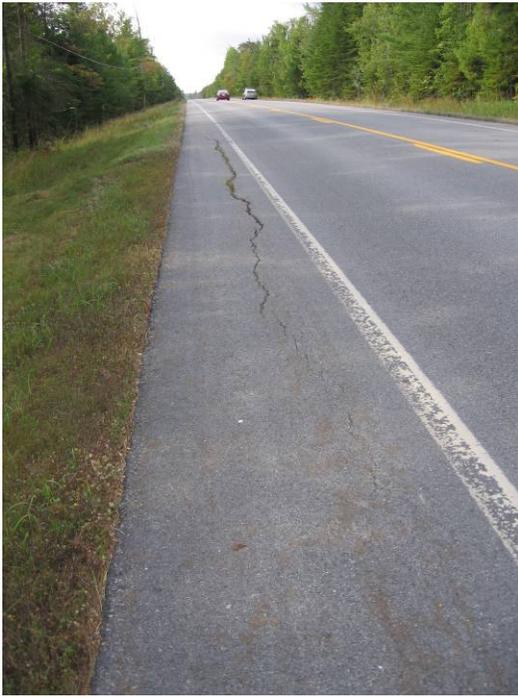
Visual evaluations were completed on September 16<sup>th</sup>, 2009. The Control Section remains in very good condition with virtually no transverse or load associated cracking. There is one significant longitudinal crack in the Northbound Lane shoulder, however, as noted in previous Interim reports. The Soil Cement Section has three (3) full width transverse cracks and numerous partial width cracks. In addition, there is approximately 250 ft. of load associated longitudinal cracking in the lanes. Exact length and location of cracks were not documented for this Interim report but will be for the final inspection and report.

Photo 2: Shoulder Crack in Control Section – 2009

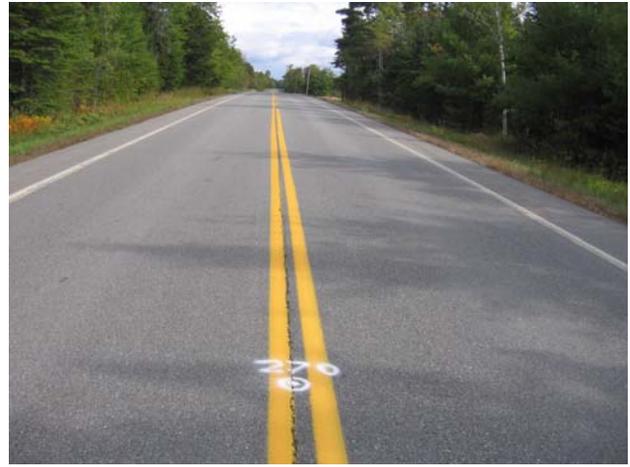
Photo 3 – Control Section

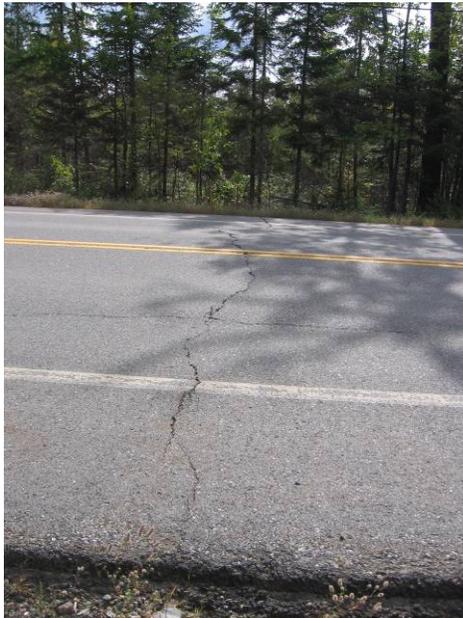
Photo 4 – Soil Cement Transverse Cracking

Transverse and longitudinal cracking in the soil cement section is a concern. A general observation during the 2009 field inspection is that the majority of the entire project has this type of cracking as well. It is possible that too much cement (4%) may have been used on this project making the pavement section less

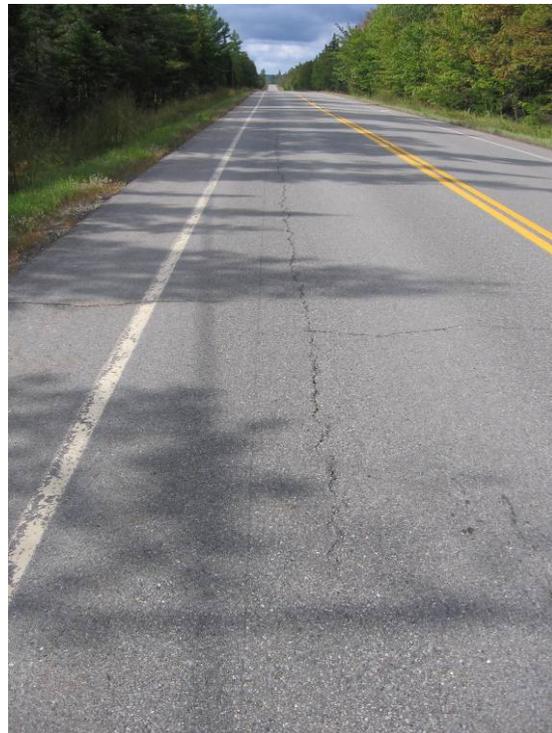
Photo 5 – Soil Cement Longitudinal Cracking
